Degradation Mechanisms in Cylindrical Li-Ion Batteries During Cell Cycling

*L. Buannic,¹ F. Aguesse,¹ E. Sarasketa-Zabala,²
E. Gucciardi,¹ E. Bekaert¹*

Battery Power 2017

Dallas, May 17th

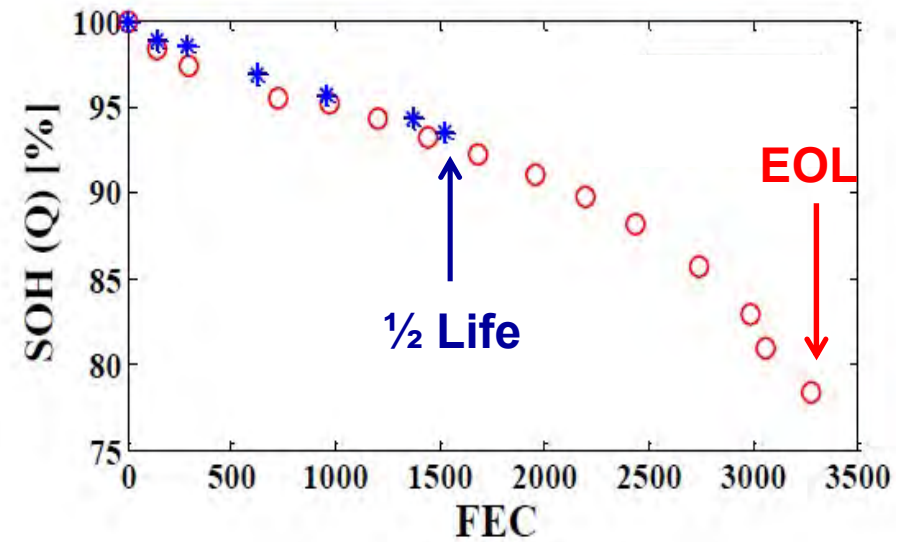
Selection of Cells to Be Opened

- **Pristine Battery**
as received from the manufacturer, discharged
- **Beginning of Life (BOL)**
after conditioning and internal procedure for first check-ups
- **Half Life ($\frac{1}{2}$ Life)**
aged for 1521 FEC, 93% SOC
- **End of Life (EOL)**
aged for 3276 FEC, 79.5% SOC

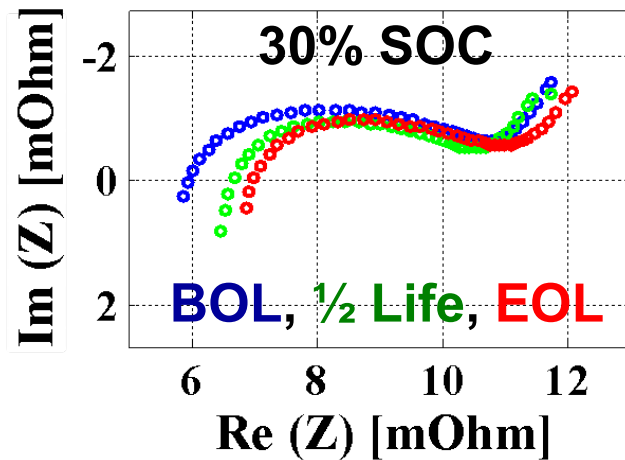
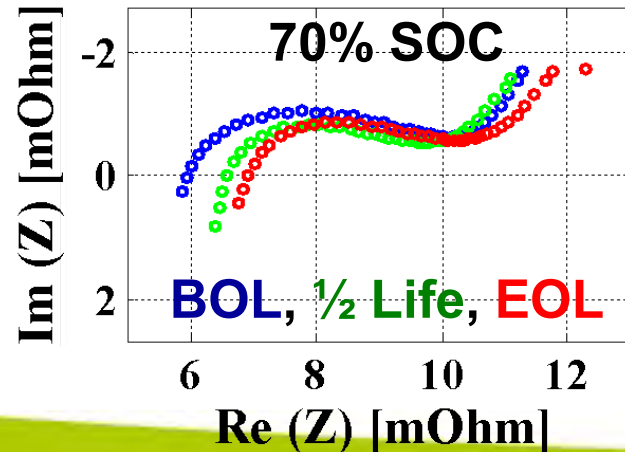
Cell Degradation: 1st Hints

- ❖ **SOC:** no effect on cell resistance
- ❖ **Cycling:** increase of electrolyte resistance
→ Possible growth of SEI layer
- ❖ **Cycling:** Fading of anodic capacity
→ Possible degradation of graphite

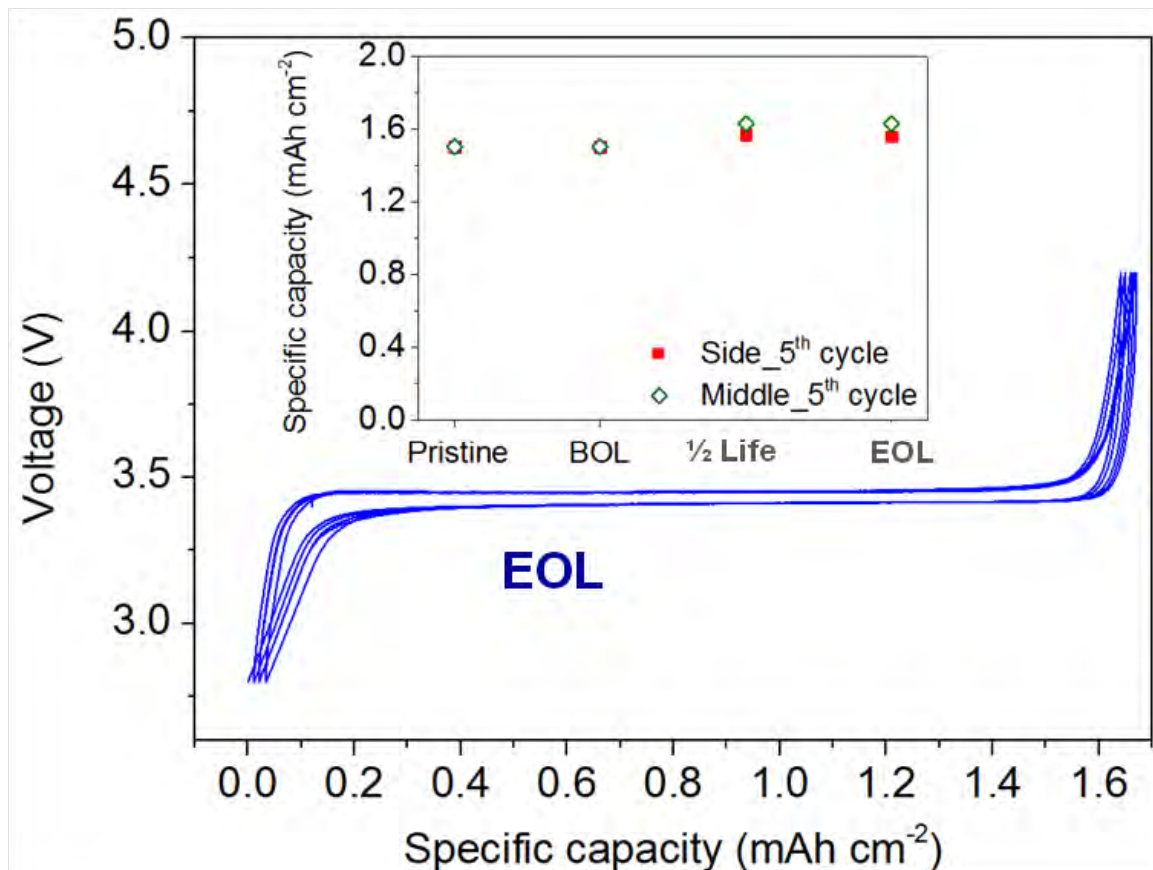
LiFePO₄ cathode vs. Li metal

❖ **Upon ageing:**
No loss of capacity
No additional polarization

→ **No degradation of LFP cathode**

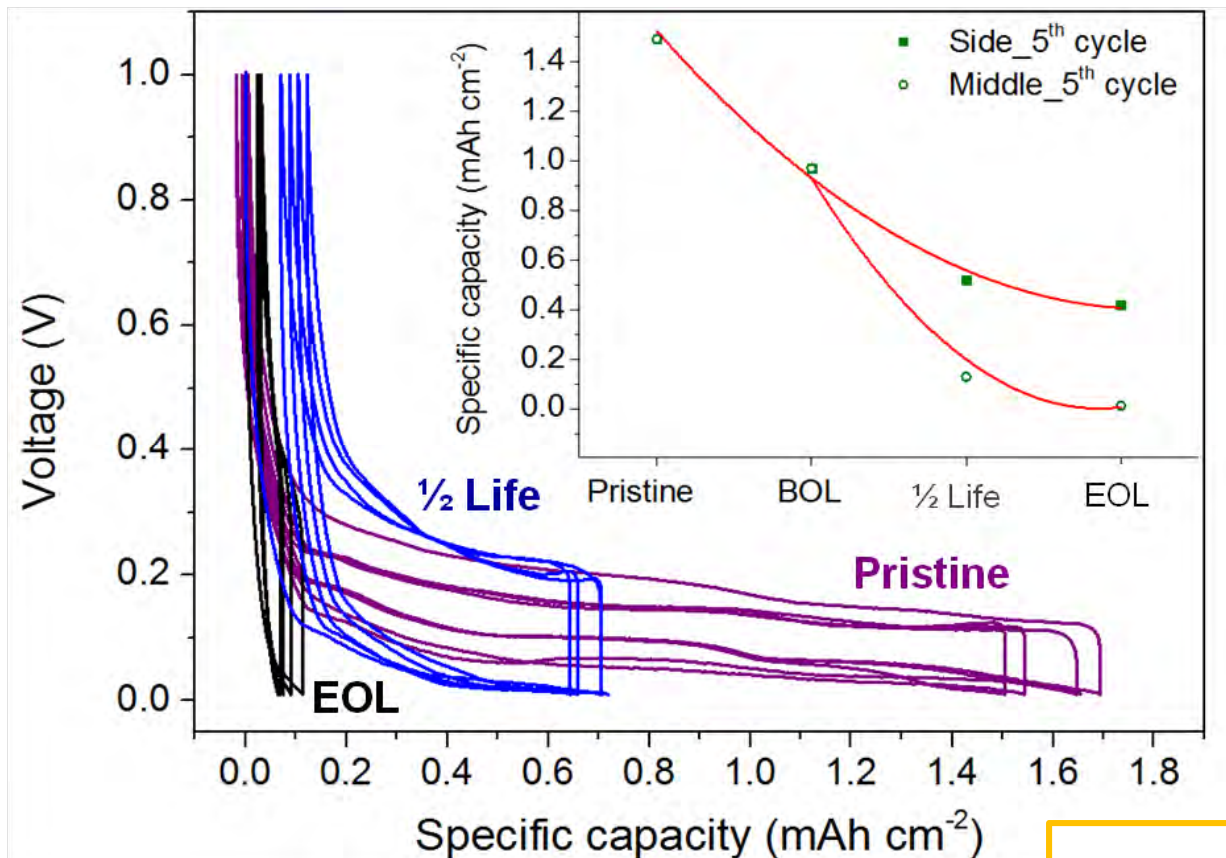
Graphite anode vs. Li metal

❖ **Upon ageing:**
Loss of capacity
Cell polarization

❖ **Increased degradation in the middle:**
Side: 60% loss
Middle: 95% loss

→ Degraded SEI layer on Graphite Surface Prevents Li⁺ Insertion into Graphite

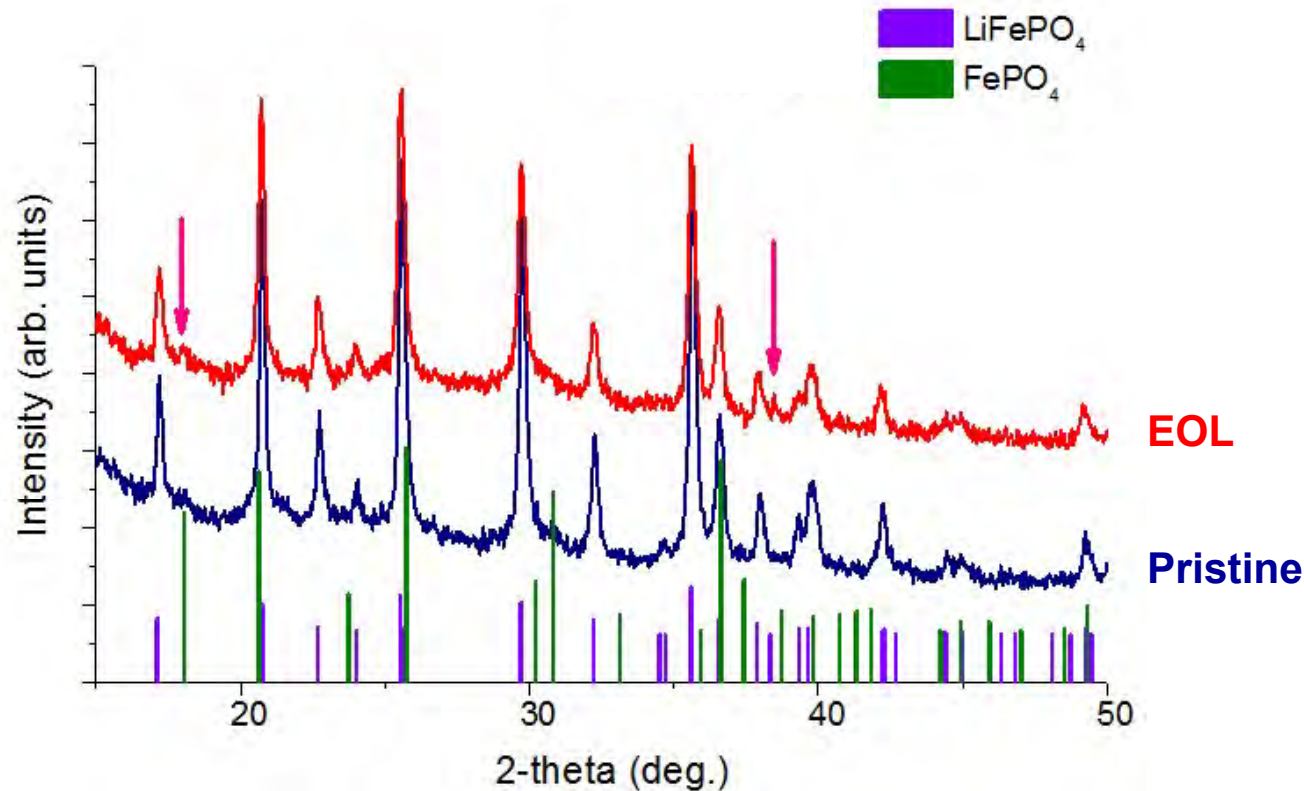
LiFePO_4 Cathode

- ❖ No structural changes observed upon ageing
- ❖ EOL: Presence of some FePO_4 after cell discharge
→ some Li^+ loss, to be related to Li plating at graphite surface

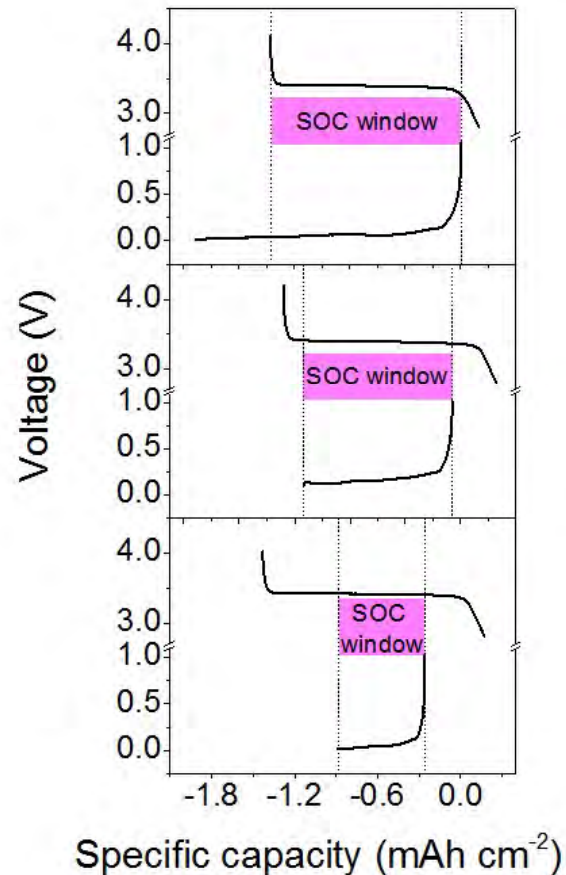
Evolution of SOC Window

❖ Growth and degradation of SEI layer at graphite electrode

❖ Li⁺ loss due to electrolyte decomposition and Li plating

→ **Diminution of available capacity within the voltage limits**
